June 20, 1977

GEORGE C. MARSHALL **SPACE
FLIGHT
CENTER**

FAILURE ANALYSIS
OF
STRUTHERS-DUNN S2GP7.25-73D
RELAY

ELECTRONIC PARTS VERIFICATION BRANCH
ELECTRONICS DEVELOPMENT DIVISION
ELECTRONICS AND CONTROL LABORATORY

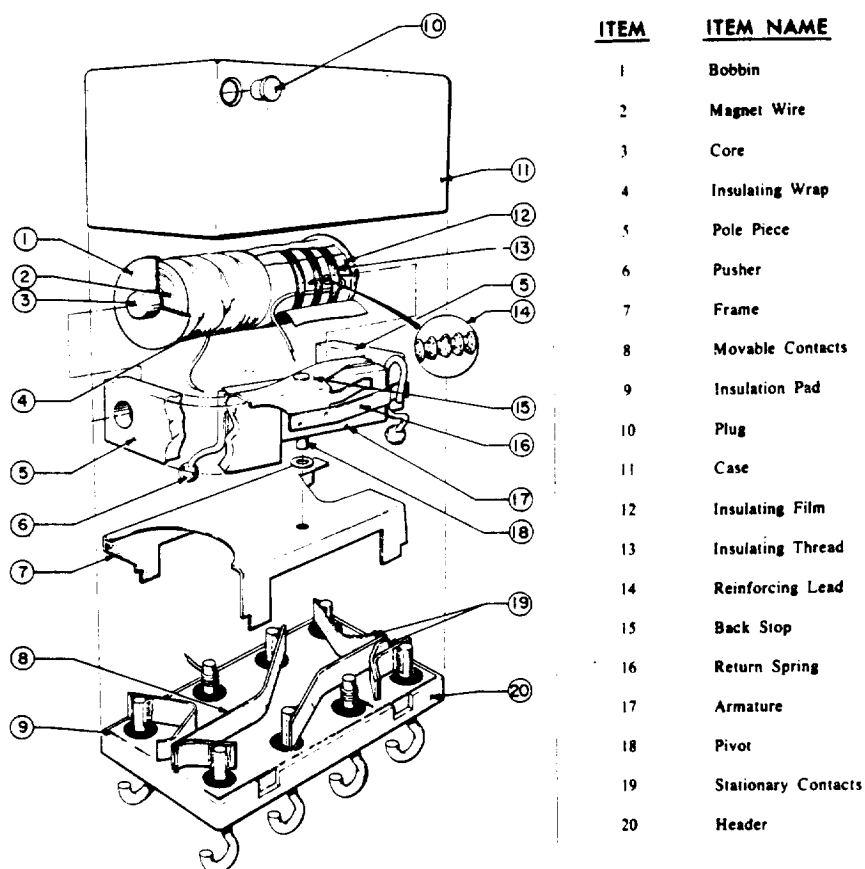
Figure 1. Typical Armature Relay Design

The relay was completely disassembled and all parts examined microscopically for wear, interference, or any anomaly which could cause binding or prevent the relay from operating. Figure 1 shows a typical armature relay design.
